BELZONA ELASTOMER VS SAND & WATER ABRASION

ID: 852

Application: *SHM-Solids Handling Machinery*

Customer Location: *Well Servicing Company / Tulsa, OK*

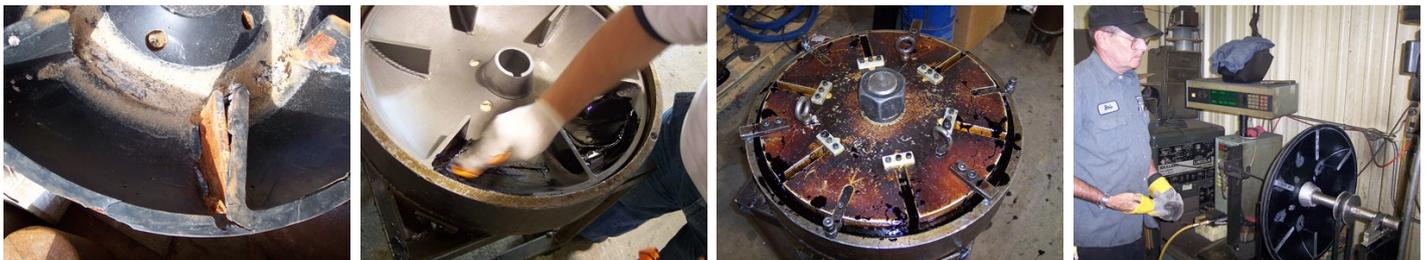
Photograph Descriptions

- * Typical wear from Oilwell service caused by sand/water at high pressure ,
- * New prepared slinger being wetted out with Belzona® 2131 ,
- * Mold fitted and filled, waiting cure ,
- * Final step - spin balancing ,

Pumping HP Sand/water slurry down a well includes a Slinger Disc which is lined with a wear material to counter the abrasion.

A forming procedure is used to mold the Belzona. After removing from mold and trimming the disc is dynamically balanced. Procedure follows a modified Belzona Know-How System SHM-9.
