Amine Regenerator Tower Receives Belzona Patch Repairs

ID: 8527

Industry: Chemical & Petrochemical
Application: TCC-Tanks and Chemical Containment Areas

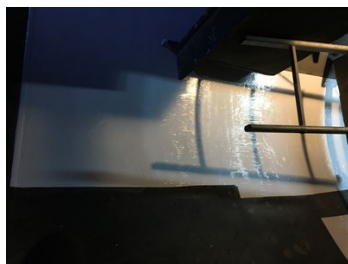
- * 1 - Metal loss picked up during inspection ,
- * 2 - Belzona 1593 applied ,
- * 3 - Close up of the coating ,

During a vessel inspection metal loss caused by corrosion was noted up to a maximum depth of 5mm.

The area was grit blasted using chilled iron. Areas of metal loss were then rebuilt with Belzona 1511 HT Metal. Two coats of Belzona 1593 were then applied to the area.
