# SF6 gas leak repair with Belzona

Industry: Power  
Application: VPF-Valves, Pipes and Fittings  
Substrate: Steel  
Products: \* Belzona 1161 (Super UW-metal) ,  
\* Belzona 5831 (ST-Barrier) ,

Customer Location: Wind farm, Australia  
Application Date: May 2021

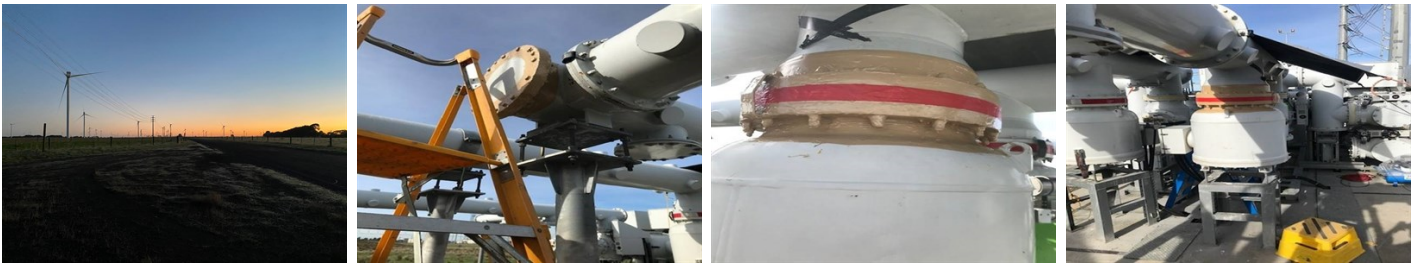
SF6 gas leaks were observed on flanges and needed to be sealed to prevent further leakage of this extremely potent greenhouse gas.

- \* Picture 1: Wind farm ,
- \* Picture 2: Leaking flange ,
- \* Picture 3: Application of Belzona 1161 & 5831 ,
- \* 4: Completed flange gas leak repair ,

Surface was prepared with power tools, such as bristles blasters and grinders to achieve a good profile for the Belzona to adhere. Belzona 1161 and reinforcing tape was applied around the outside of the flange. Then all nuts and bolts were coated with Belzona 1161. Belzona 5831 was then applied over the Belzona 1161 repair area to ensure a good seal and dress up the application

8 Flanges were successfully repaired, the client was happy and additional repairs will be carried out soon.
