Ash Silo repaired with Belzona 1818

ID: 8535

Industry: Power
Application: TCC-Tanks and Chemical Containment Areas
Substrate: 3CR12 grade stainless steel
Products: * Belzona 1818,

Customer Location: Coal fired power station, Australia
Application Date: June 2021

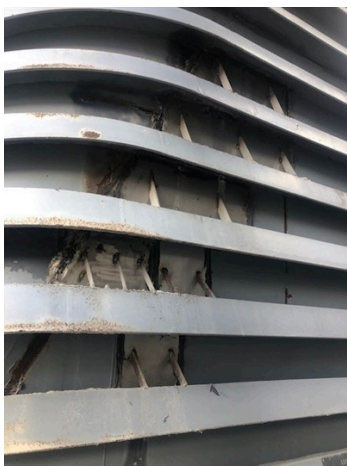
They have been experiencing rapid wear in the bottom part and particularly the Northern wall of the Bottom Ash Silo. The silo is made of 3CR12 grade stainless steel at 8.0mm thick. The wear rate is 0.25mm of wall thickness loss per month. The customer needed a quick solution to protect what metal they had left.

- * Picture 1: External view of the damaged Silo ,
- * Picture 2: Internal view of the damaged Silo ,
- * Picture 3: Belzona is applying ,
- * Picture 4: Application complete ,

There were areas in the Silo walls that had worn down from 8.0mm to 3.8mm of remaining wall thickness. Rezitech were called to offer a quick solution to reduce the metal loss and protect the remaining substrate. 20 X 1 kg kits of Belzona 1818 were applied.

The product had to be surface tolerant as there was no time to get abrasive blasting organized and staged three stories up at short notice. Also, the product had to be fast curing as they needed to get back on line as quickly as possible, and of course had to be abrasion resistant. Just the job that Belzona 1818 was designed for.
