ENGINE REPAIR WITH BELZONA

ID: 854

Application: ENC-Engines and Casings

Customer Location: Limestone producer, Troy, MO

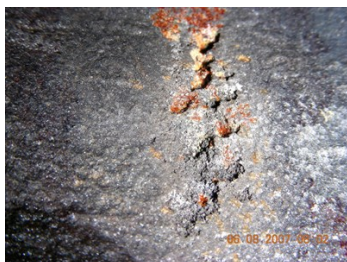
Erosion/corrosion on the cylinder block behind the cylinder liners allowed engine coolant to leak into the lubricating oil causing an engine failure.

* Komatsu 900 loader , * Typical damage , * Completed surface preparation , * Finished repair to 1 of the 11 damaged areas ,

Application carried out in accordance with Belzona Know-How System Leaflet ENC-6. Particular attention paid to removing entrained antifreeze before preparing surface and applying Belzona.
