# Hydro Power Kaplan Turbine Case Coated with Belzona

ID: 8544

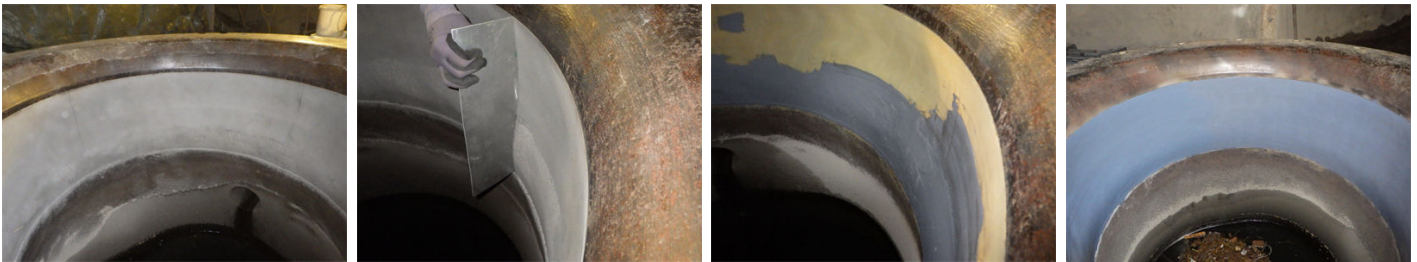
The impeller shell of the Kaplan turbine at a Hydro power plant was badly damaged by cavitation and wear over several decades.

- \* Image 1: The turbine casing after sandblasting. ,
- \* Image 2: Before the reconstruction, a template of the target shape was made. ,
- \* Image 3: Belzona 1311 applied to rebuild the profile. ,
- \* Image 4: Complete with a top layer of Belzona 1321 ,

Blasted to 90µm roughness according to Testex with abrasive Asilikos 0.2-1.4 (carried out by Bauschutz) Residual moisture burned out of the casting Flaws slightly raised and rebuilt with Belzona 1311 - curing: 18 hours at 15 ° C Reconstructed areas ground to the target contour Swept jacket - Belzona 1311 spots were slightly roughened and bare steel surfaces were derusted Coating of the jacket with two layers of Belzona 1321 - the first layer was completely covered within 2 hours - total target layer thickness: 600 µm Applications carried out in line with Belzona system leaflet CEP-5
