Belzona in the Cement Industry

ID: 8545

Application: SHM-Solids Handling Machinery

Ball Mill 4000mm diameter in Germany.

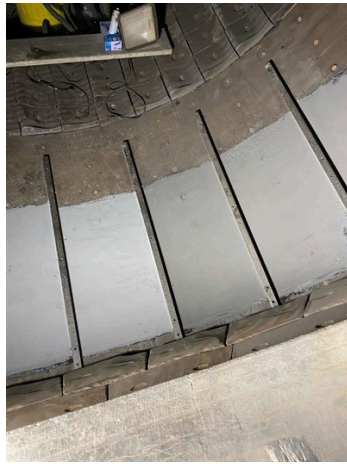
- * 1: Ball mill in a cement plant (diameter 4000mm) ,
- * 2: Belzona 4111 and steel base for the right height (for Belzona 4111 and 1812 with two different templates) ,
- * 3: Every second area complete rebuild with Belzona 1812 (4mm) ,
- * 4: After removing the steel base 1812 applied in the rest of the area ,
