Belzona in the Cement Industry

ID: 8545

Industry: Mining & Quarrying
Application: SHM-Solids Handling Machinery

Customer Location: Germany
Application Date: April 2020

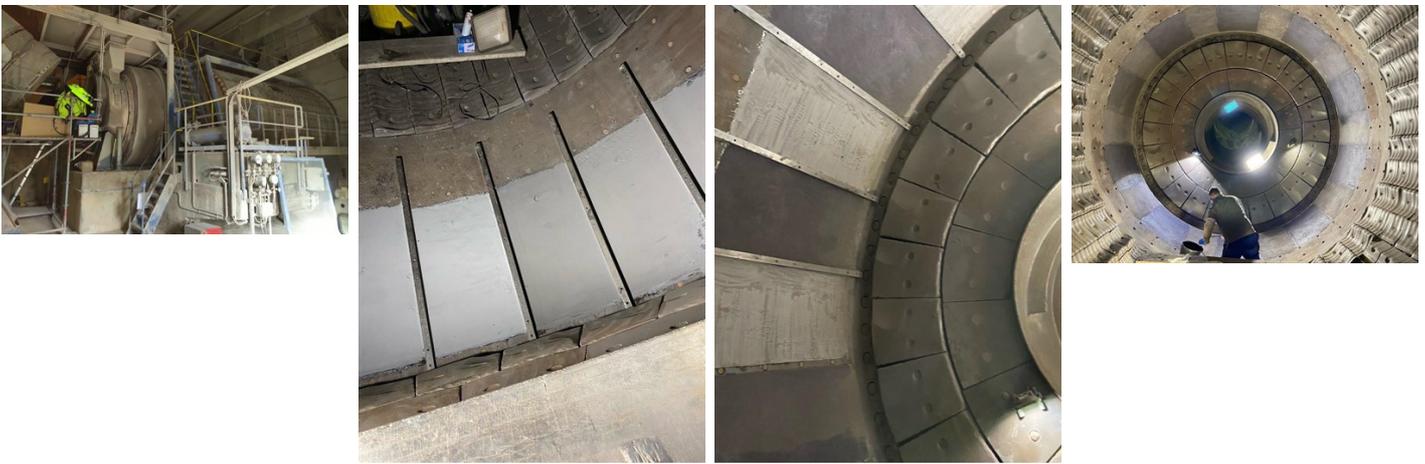
Photograph Descriptions

In the mill there is a chamber for pre-drying with lift paddles. Under the paddles the wall eroded over years from cement dust (between 0 and 12mm). When the client changed the paddles, they wanted an inner wall surface like new (for a complete bearing area).

- * 1: Ball mill in a cement plant (diameter 4000mm) ,
- * 2: Belzona 4111 and steel base for the right height (for Belzona 4111 and 1812 with two different templates) ,
- * 3: Every second area complete rebuild with Belzona 1812 (4mm) ,
- * 4: After removing the steel base 1812 applied in the rest of the area ,

Application was carried out in accordance with modified version of the Belzona Know-How System Leaflet SHM-7.
