Belzona Protects a Concrete Floor from Future Oil Ingress

ID: 8546

Application: *FPA-Floor Problem Areas*

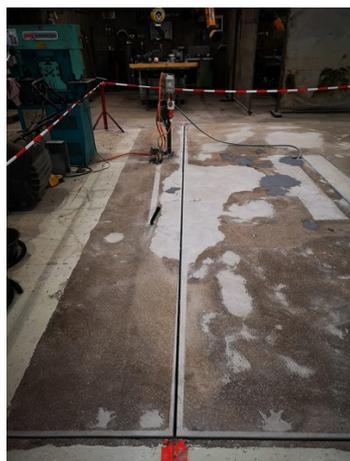
The concrete (70m²) was softened and damaged due various oils being spilled over the area.

Removal and installation of the defective floor by scarifier/grinder.

The damaged floor was mechanically removed, cleaned and rebuilt, various areas sealed using Belzona 1111 and Belzona 1212. Followed by 2 coats of Belzona 5231. Finally, new expansion joints were formed using Belzona 4521. The application was carried out in accordance with Belzona System Leaflet FPA-01 & FPA-06

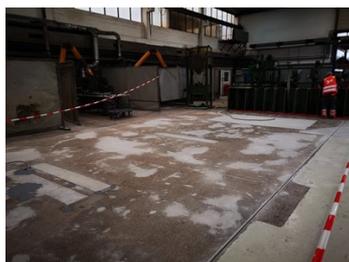
Cutting expansion joints and preparations for coating.

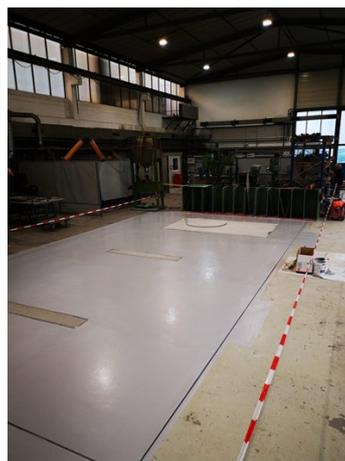
2x Coats of Belzona 5231 including recessing for new system parts.
