# Belzona Protects a Concrete Floor from Future Oil Ingress

**Industry:** General Industry  
**Application:** FPA-Floor Problem Areas  
**Substrate:** Concrete  
**Products:** Belzona 1111 (Super Metal), Belzona 1212, Belzona 4521 (Magma-Flex Fluid), Belzona 5231 (SG Laminate)

**Customer Location:** Switzerland, Vigier Perry  
**Application Date:** April 2021

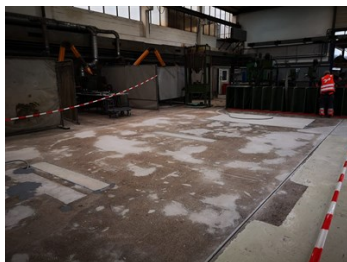
Cutting expansion joints and preparations for coating.

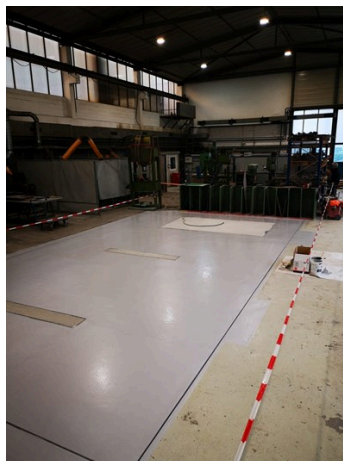
2x Coats of Belzona 5231 including recessing for new system parts.
