Cargo ship bow thruster repaired with Belzona

Industry: *Marine*
Application: *SOS-Ships and Offshore Structures*

Substrate: *Carbon Steel*
Products: ** Belzona 1311 (Ceramic R-Metal) ,*

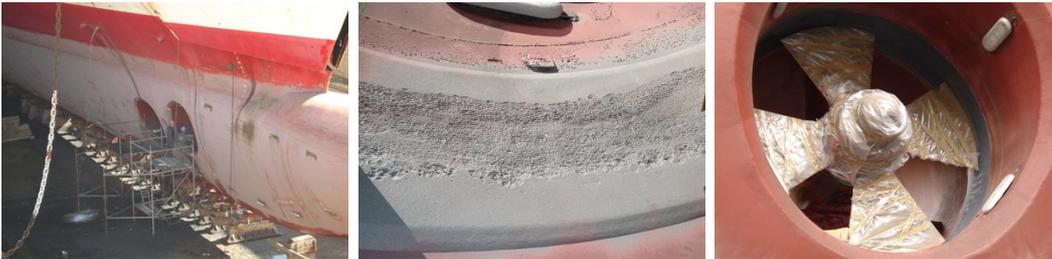
Photograph Descriptions

Thruster tunnel suffers from erosion/corrosion that leads to cavitation and pitting

- * 1 : Vessel out of water ,
- * 2 : Significant pitting on upper surfaces ,
- * 3 : Completed Application ,

The repair was carried out in accordance with Belzona System Leaflet SOS 02. Damaged area was roughened to have a minimum profile depth of 3 mil and degreased with Belzona 9111. Belzona 1311 was applied to fill the pitting.
