# Cargo ship bow thruster repaired with Belzona

ID: 8553

Industry: *Marine*  
Application: *SOS-Ships and Offshore Structures*

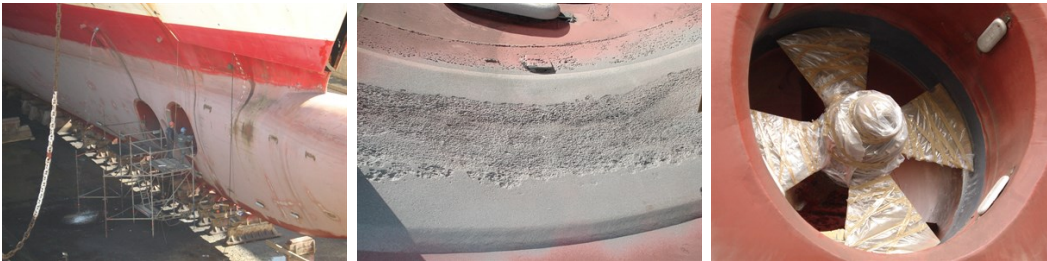
## Photograph Descriptions

*Thruster tunnel suffers from erosion/corrosion that leads to cavitation and pitting*

- \* 1 : Vessel out of water ,
- \* 2 : Significant pitting on upper surfaces ,
- \* 3 : Completed Application ,

The repair was carried out in accordance with Belzona System Leaflet SOS 02. Damaged area was roughened to have a minimum profile depth of 3 mil and degreased with Belzona 9111. Belzona 1311 was applied to fill the pitting.
