# Belzona prevents wear on an ash slurry mixer

ID: 8555

Industry: Power  
Application: SHM-Solids Handling Machinery

Customer Location: Washington  
Application Date: February 2021

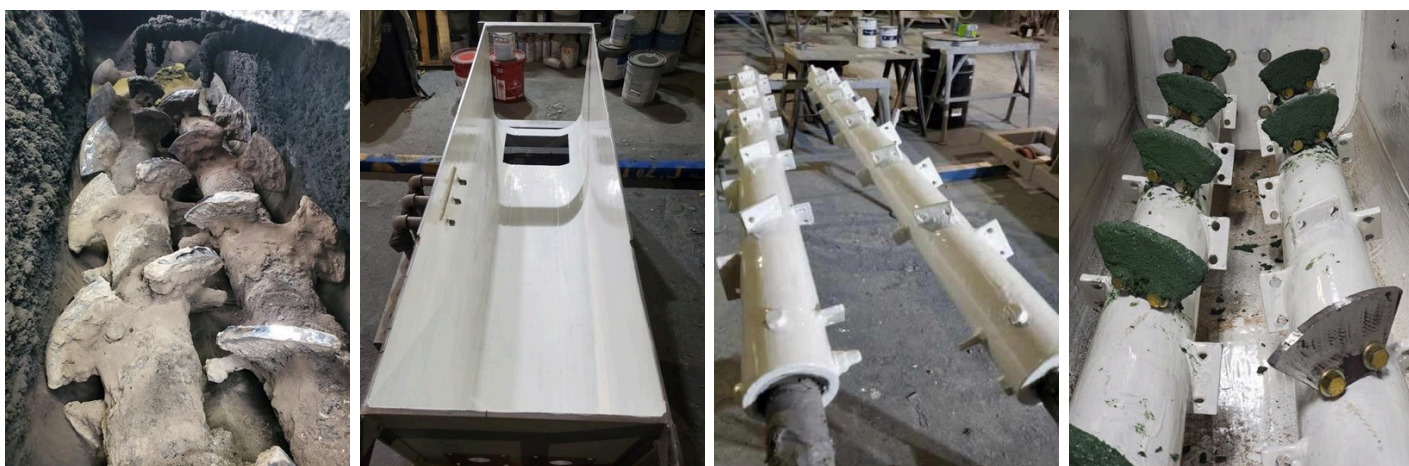
## Photograph Descriptions

The paddles on their ash slurry mixer would wear down to less than half of their original length in 3 months forcing them to be replaced. The original paddles were made from hardox steel. The mixer box and shafts had some mild wear and corrosion as well.

- \* 1. Original condition ,
- \* 2. Box coated with Belzona 1331 ,
- \* 3. Shafts coated with Belzona 1331 ,
- \* 4. Paddles being coated with Belzona 1813 ,

The mixer box and shafts were grit blasted and the Belzona 1331 was applied in two layers by hand. The new mixer paddles were hand ground and the Belzona 1813 was applied by hand.

The original method of replacing the paddles was causing thousands of dollars in new blades, man hours, and shutdowns every three months. By using this Belzona solution, the mixing box and paddles have been in operation for over six months with absolutely no sign of any wear. In six months, the cost of the Belzona solution has already been more than paid for.
