# VOLUTE PUMP INTERNAL LINING REPAIRED WITH CHEMICAL RESISTANT PROTECTIVE COATING

ID: 8557

Customer Location: *POWER PLANT RAS LAFFAN QATAR*

Application Date: *DECEMBER 2020*

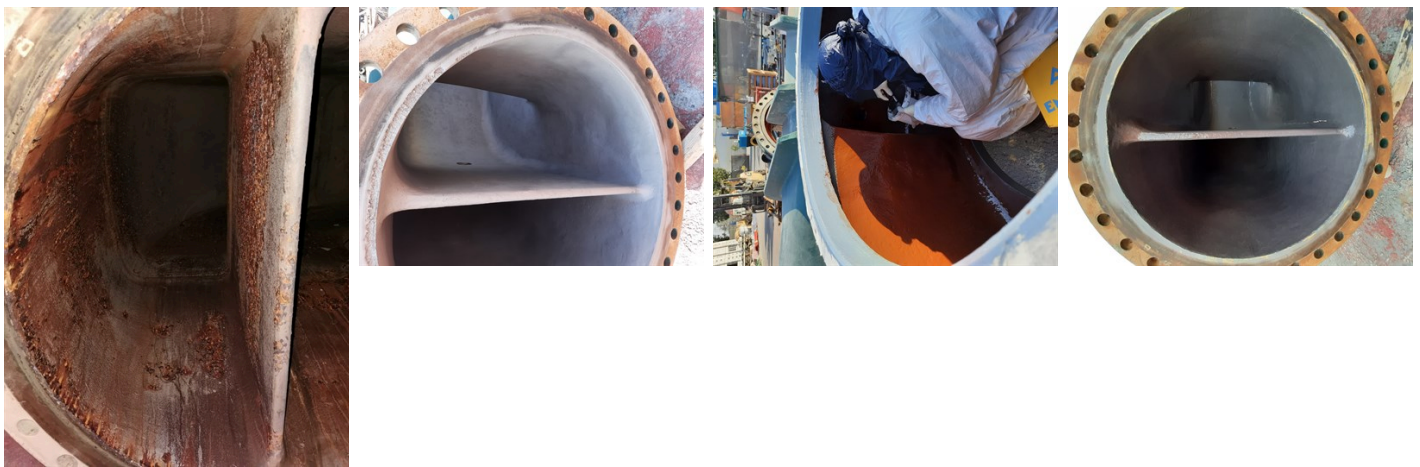
*INTERNAL LINING WAS SEVERELY DAMAGED, GENERAL CORROSION ALL OVER THE SURFACE IS EVIDENT AND DEEP PITTING ON INLET SITTING AREA AND ON OUTLET FLANGE FACE*

- \* 1) APPEARANCE OF THE PUMP BEFORE BLASTING ,
- \* 2) PUMP AFTER BLASTING ,
- \* 3) DURING COATING APPLICATION ,
- \* 4) APPLICATION COMPLETE WITH BELZONA 4311 ,

THE VOLUTE PUMP HAS BEEN RUNNING FOR 3 YEARS WITHOUT INTERRUPTION, RESULTING TO FAILURE OF EXISTING INTERNAL COATING

SURFACE PREPARATION BY GRIT BLASTING IS CARRIED OUT TO REMOVE RUSTS AND CORROSION RESIDUES AS WELL AS TO EXPOSE UNFORSEEN PITTING TO EVALUATE THE AMOUNT OF CAULKING MATERIAL TO BE USED. REBUILDING APPLICATION ON ALL EXPOSED PITTING TAKES PLACE AFTER BLASTING IS COMPLETED AND CURED FOR 2 HOURS. AFTER CURING, SWEEP BLASTING HAS BEEN CONDUCTED ALL OVER THE SURFACE WHICH INCLUDES THE SURFACE OF THE REBUILDING MATERIAL, FOLLOWED BY APPLICATION

OF BELZONA 4311 CHEMICAL RESISTANT COATING IN TWO COAT SYSTEM.
