Heat Exchanger Repair & Coating with Belzona

ID: 8558

Application: *HEX-Heat Exchangers*

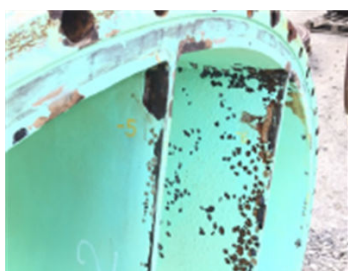
- * 1 - Damage to the coating & underlying metal ,
- * 2 - Surface preparation & rebuilding with Belzona 1311 ,
- * 3 - End cover coated with Belzona 1321 ,
- * 4 - Belzona 1321 applied ,

A heat exchanger had suffered damage from erosion & corrosion in service.

The existing coating was removed during the grit blast preparation. The metal was prepared to SA2.5 & 75 microns. Any areas of metal loss were repaired using Belzona 1311 Ceramic R metal. Two coats of Belzona 1321 Ceramic S Metal were then applied for future erosion/corrosion protection.
