Bush housing bonded in place with Belzona

ID: 8559

Application: *ENC-Engines and Casings*

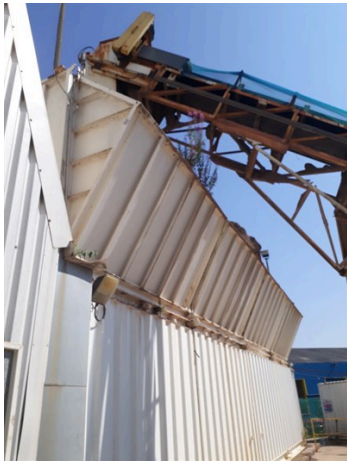
- * 1 - Conveyor system ,
- * 2 - Surface preparation on the housing ,
- * 3 - Bushing to be bonded in place ,
- * 4 - Belzona 1111 Supermetal applied & bushing bonded ,

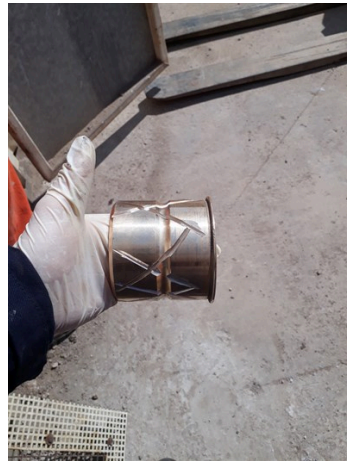
A bush housing had become oversize due to wear & corrosion. The bush was spinning whilst the machinery was in operation, this was causing further wear.
