Bush housing bonded in place with Belzona

ID: 8559

Application: *ENC-Engines and Casings*

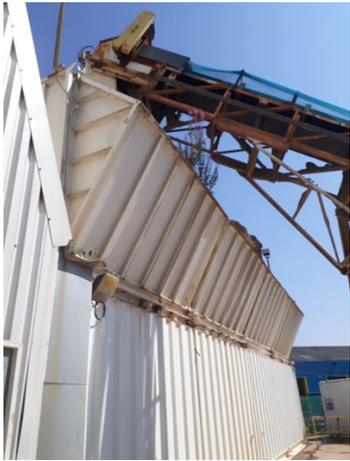
- * 1 - Conveyor system ,
- * 2 - Surface preparation on the housing ,
- * 3 - Bushing to be bonded in place ,
- * 4 - Belzona 1111 Supermetal applied & bushing bonded ,

A bush housing had become oversize due to wear & corrosion. The bush was spinning whilst the machinery was in operation, this was causing further wear.
