Repair of drinking water tank with Belzona 5811DW2

ID: 8560

Customer Location: Poland
Application Date: July 2021

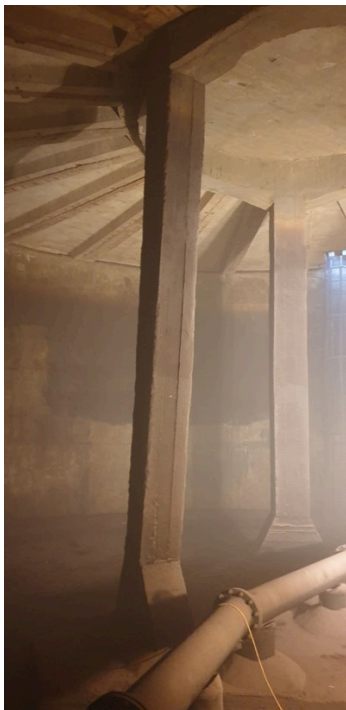
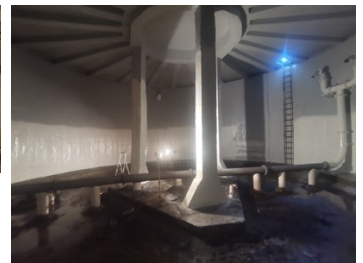
Photograph Descriptions

The concrete walls of the water tank had corroded over time leading to deterioration of the substrate subsequently leading to a poorer quality water quality.

- * Image 1: Inside of the Water Tank ,
- * Image 2: Re-Build of the Concrete using Belzona 4111 ,
- * Image 3: Spraying Belzona 5811DW2 ,
- * Image 4: Completed Application ,

Renovation of a Water tank on site using a Belzona Drinking Water approved coating.

The Belzona products were applied in accordance with the Belzona System Leaflet TCC_5.

Belzona 5811DW2 is a WRAS approved coating for Potable Water, spray applied allowing for a quick and easy return to service.
