Belzona Strengthens Nozzles of Closed Drain Drum on Offshore Platform

ID: 8569

Industry: Oil & Gas

Application: VPF-Valves, Pipes and Fittings

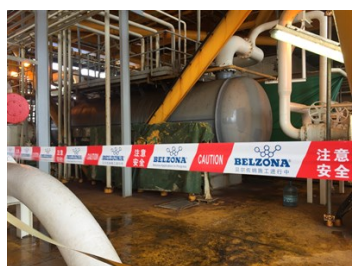
- * 1. Surface preparation with water blasting ,
- * 2. Condition of Nozzles after sandblasting ,
- * 3. Complete application of Belzona Superwrap II ,
- * 4. View of nozzles after 3 years ,

The repairs were designed in accordance with ISO24817 standard. The application was completed by Belzona trained and validated installers in accordance with Belzona Know-How System Leaflet VPF-11. Belzona supervisor and the on-site representative supervised the whole process. The whole application involved 2 one and half-inch nozzles, 14 two-inch nozzles, 1 three-inch nozzle and 4 four-inch nozzles.

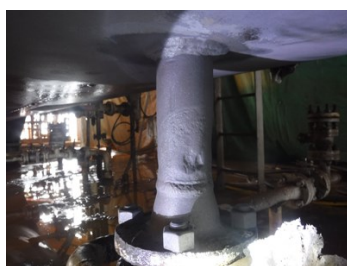
The nozzles of closed drain drum had developed thin-wall defect due to CUI.

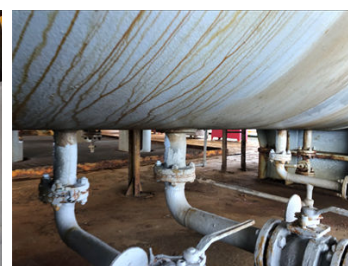
For conventional welding, the whole closed drain drum need to be shut down and isolated, with thorough cleaning and water injection, which costs at least 15 days of downtime and affects the production. Welding in confined space may also cause hazards. Therefore, the customer has been looking for the solutions with no hot work required but also accepted by classification society. Meeting the standard of ISO24817 and ASME PCC-2, Belzona Superwrap II can repair the nozzles of pressure vessels on-site, with no downtime or hot work required. The application is still in good condition after 3 years.
