Belzona Strengthens Nozzles of Closed Drain Drum on Offshore Platform

ID: 8569

Industry:	Oil & Gas	Customer Location:	China
Application:	VPF-Valves, Pipes and Fittings	Application Date:	2017
Substrate:	Carbon Steel		
Products:	<ul style="list-style-type: none"> * Belzona 1511 (Super HT-Metal) , * Belzona 1983 (Belzona Superwrap II Resin) , * Belzona 9381 , * Belzona 9382 , * Belzona 9111 (Degreaser) ,

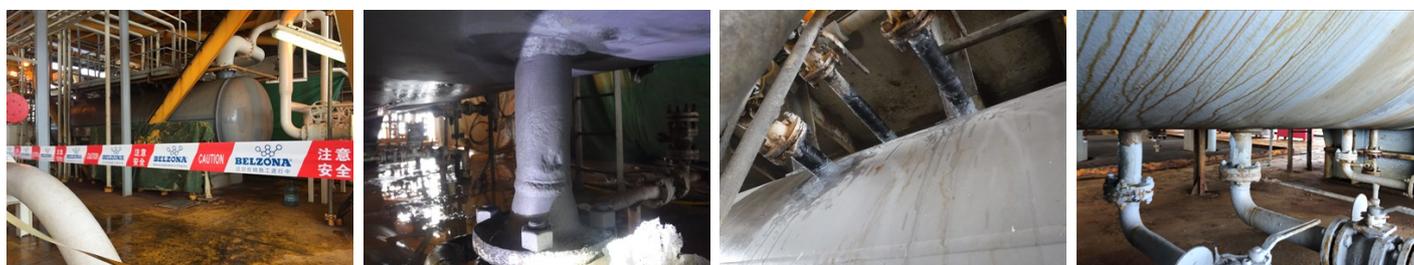
Photograph Descriptions

The nozzles of closed drain drum had developed thin-wall defect due to CUI.

- * 1. Surface preparation with water blasting ,
- * 2. Condition of Nozzles after sandblasting ,
- * 3. Complete application of Belzona Superwrap II ,
- * 4. View of nozzles after 3 years ,

Nozzles of closed drain drum on offshore platform suffering from corrosion and significant thickness loss. The design pressure is 0.35MPa, the design temperature is -19°C~110°C.

The repairs were designed in accordance with ISO24817 standard. The application was completed by Belzona trained and validated installers in accordance with Belzona Know-How System Leaflet VPF-11. Belzona supervisor and the on-site representative supervised the whole process. The whole application involved 2 one and half-inch nozzles, 14 two-inch nozzles, 1 three-inch nozzle and 4 four-inch nozzles.

For conventional welding, the whole closed drain drum need to be shut down and isolated, with thorough cleaning and water injection, which costs at least 15 days of downtime and affects the production. Welding in confined space may also cause hazards. Therefore, the customer has been looking for the solutions with no hot work required but also accepted by classification society. Meeting the standard of ISO24817 and ASME PCC-2, Belzona Superwrap II can repair the nozzles of pressure vessels on-site, with no downtime or hot work required. The application is still in good condition after 3 years.
