# Belzona Strengthens Nozzles of High-pressure Flare Scrubber on Offshore Platform

ID: 8570

Application: VPF-Valves, Pipes and Fittings

Application Date: 2017

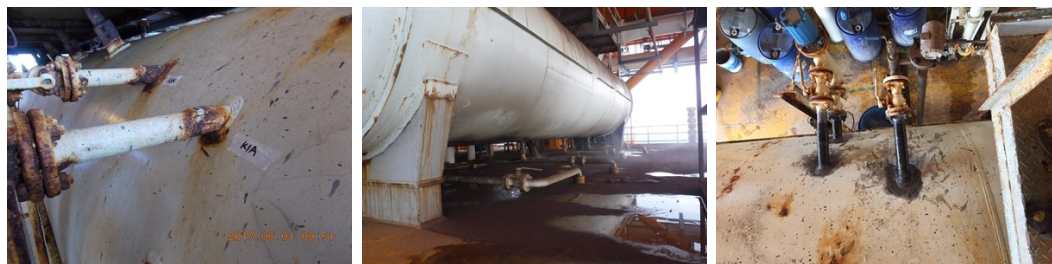
Due to the damage of the original insulation layer, the nozzle of the high-pressure flare scrubber was corroded under the insulation layer (CUI). The thickness of the nozzle was seriously reduced.

- \* 1. Nozzles with serious corrosion problems ,
- \* 2. Surface preparation with water blasting ,
- \* 3. Complete application of Belzona Superwrap II ,

Nozzles of high-pressure flare scrubbers on offshore platform suffering from corrosion and significant thickness loss. The design pressure is 1.035MPa, the design temperature is -48°C~100°C.

The repairs were designed in accordance with ISO24817 standard. The application was completed by Belzona trained and validated installers in accordance with Belzona Know-How System Leaflet VPF-11. Belzona supervisor and the on-site representative supervised the whole process. The whole application included 2 one and half-inch nozzles, 10 two-inch nozzles, 4 three-inch nozzles and 1 four-inch nozzle.

For conventional welding, the whole high-pressure flare scrubber need to be shut down and isolated, with thorough cleaning and water injection, which costs at least 15 days of downtime and affects the production. Welding in confined space may also cause hazards. Therefore, the customer has been looking for the solutions with no hot work required but also accepted by classification society. Meeting the standard of ISO24817 and ASME PCC-2, Belzona Superwrap II can repair the nozzles of pressure vessels on-site, with no downtime or hot work required. The application is still in good condition after 3 years.
