BELZONA SUPERWRAP II RETURNS PIPING BACK TO SERVICE IN 48 HOURS

ID: 8577

Application: VPF-Valves, Pipes and Fittings

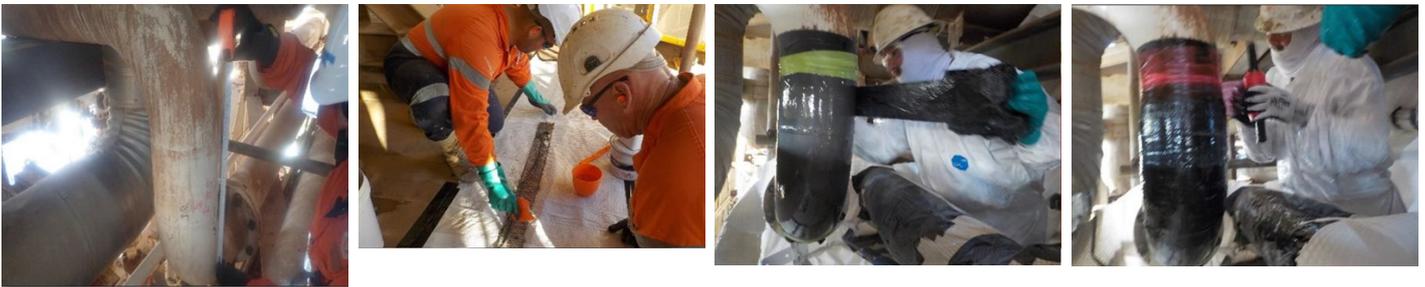
The 220mm diameter pipe had developed a critical (Class 3) thin wall defect at the bend. The operating temperature was 95°C and the operating pressure was 10 bar. The total defect length was 280mm in axial.

- * 1. Measuring the corroded pipe ,
- * 2. Wetting out the Reinforcement Sheet ,
- * 3. Wrapping the pipe ,
- * 4. Applying the Release Film over the wrap ,

The application was completed in accordance with Belzona Know-How System Leaflet VPF-11. The defect area was abrasive blasted to SA 2.5 with a 75 microns profile. Belzona SuperWrap II was applied in accordance with the engineered design as a 6 wrap system, using Belzona 1983 resin to provide a further 12 years service life.
