Belzona Cold Plate Bonding Reinforces and Repairs Silos

Application: TCC-Tanks and Chemical Containment Areas

Substrate: Carbon steel

Corrosion repairs needed to 8 x Nickel Storage Silos.

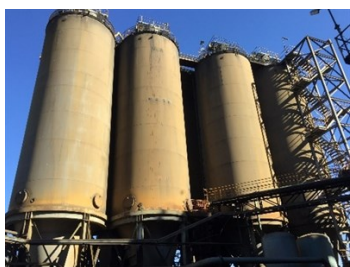
- * 1. The 8 x Nickel Storage Silos. ,
- * 2. Pitted and corroded Silo wall. ,
- * 3. Plates bonded in place going around the Silo. ,
- * 4. Completed application. ,

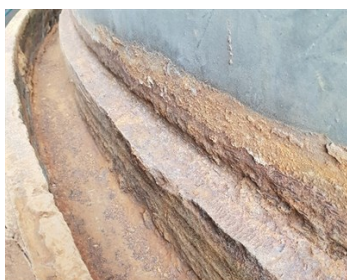
Inspections were carried out on the Silos and they were found to have severe corrosion loss to the bottom sections of all Silos. Because the Silos are internally coated welding was not an option.

The application was carried out by Cold Bonding 200mm x 1m rolled plates with Belzona in accordance with Belzona Know-How System Leaflet TCC-1. After abrasive blasting, all corrosion holes were first repaired by filling with Belzona 1111. Belzona 1111 was then applied to the plates which were bonded into place. Belzona 1121 was used when temperatures rose above 35°C to allow more working time.
