BELZONA REBUILDS 1.5M DIAMETER CONDENSER FLANGE FACE

ID: 8579

Exhaust Condenser Flange Rebuild.

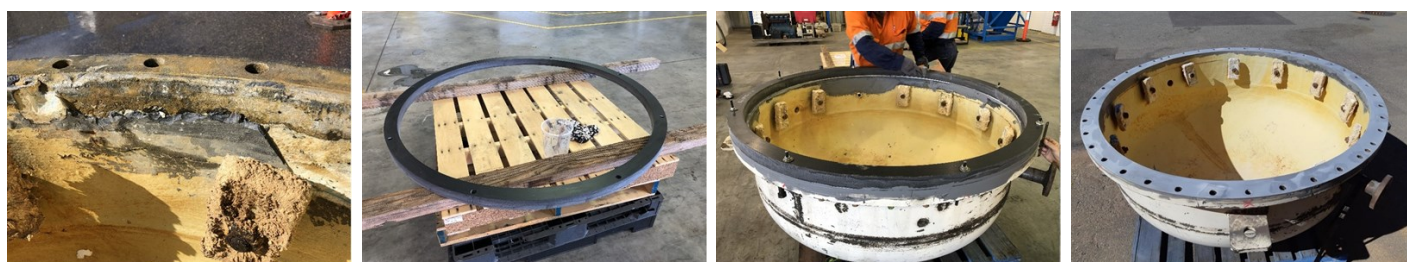
Photograph Descriptions

The previous repair on the Condenser Flange had failed and the customer was fearing that it would start leaking. This would cause unplanned downtime costing thousands of dollars.

- * 1. Close up of the damaged flange. ,
- * 2. 1.5m diameter Flange Former. ,
- * 3. Flange Former bolted in place. ,
- * 4. Completed application. ,

The application was carried out in accordance with Belzona System Leaflet VPF 13 by using a 1.5m diameter, 50mm thick, flat Flange Former coated with Belzona 9411 and left to dry. Belzona 1121 was applied to the flange face and using a plastic applicator with a “V” cut out, was shaped all around with a 6mm high peak in the center. 2mm spacers were placed evenly all round to ensure the Former would sit level when bolted down. 1mm thick Belzona 1121 was then applied to the Former before bringing the two together and bolting up the former. The Belzona 1121 was left overnight to cure before gently removing the Former.
