BELZONA RE-SURFACES WATER PARK FLOORS

ID: 858

Customer Location: Water Park - Oklahoma

Application: FPA-Floor Problem Areas

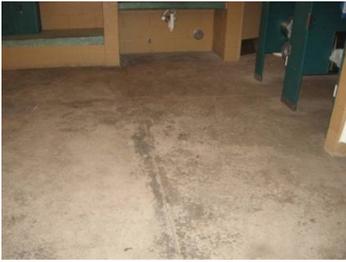
* Bathroom floors before application. , * Bathroom floors after Belzona® 5111 was applied. , * Outside surfaces before application. , * Outside surfaces after Belzona® 5111 application. ,
