# BELZONA REBUILDS NOT ONE BUT TWO 250-YEAR-OLD STONE STAIRCASES

**Industry:** Buildings & Structures  
**Application:** FPA-Floor Problem Areas  
**Substrate:** Stone  
**Products:** \* Belzona 4911 (Magma TX Conditioner) ,  
\* Belzona 4131 (Magma Screed) ,  
\* Belzona 9411 (Release Agent) ,

**Customer Location:** Essex, UK  
**Application Date:** August 2021

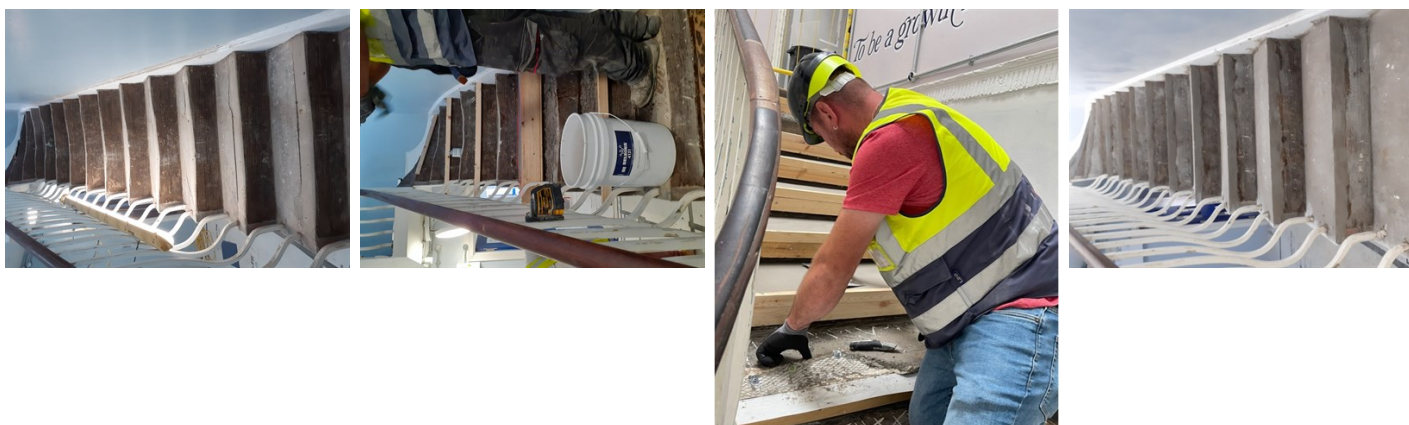
- \* 1. Worn stone steps of upper staircase prior to application showing wear up to 40mm in the centre of the step. ,
- \* 2. Wooden shuttering in place steps conditioned and Belzona 4131 being applied. ,
- \* 3 The main staircase during application, showing the perforated mesh reinforcing sheet over the failed historic repair. ,
- \* 4. Upper staircase application completed awaiting covering and grip nosings. ,

The first staircase was badly worn from 250 years of use, making them a health and safety concern. Some steps had worn up to 40mm in the centre The second main feature curved staircase had previous historic repairs that had failed again also making this feature staircase a health and safety concern. Both staircases were built in stone with wrought iron balustrades.

The steps were worn smooth, therefore, the surfaces needed to be roughened with a grinder. Wooden shuttering, coated in Belzona

9411 Release Agent was laser aligned and installed to ensure the correct level to each step. Each step was then coated with Belzona 4911 TX Conditioner prior to the application of Belzona 4131 Magma Screed. The main feature steps had to be reinforced with perforated mesh as there was a 30mm overhang to be incorporated into the repair.
