Belzona SuperWrap II for Pitted Piping

ID: 8592

Customer Location: Houston
Application Date: March 2020

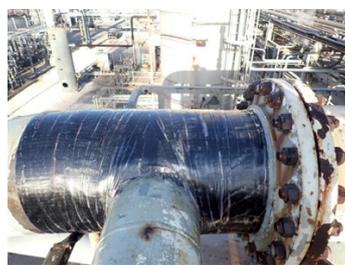
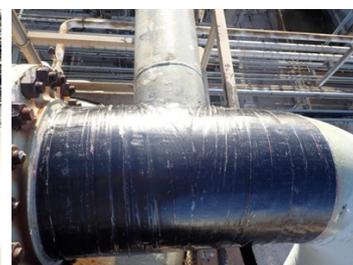
- * 1. Defective Asset ,
- * 2. Graphic for Design Package ,
- * 3-4. Final Repair ,

Localized corrosion in the form of deep pits was on the verge of holing through.

Piping near a cooling tower was severely corroded due to cooling tower mist.

Wire brush preparation was performed around critical defects. Belzona 1212 was then used to cover critical defects. Once Belzona 1212 became machinable, a MBX was used to create an SSPC-SP 11 surface cleanliness level on the surrounding good metal. Belzona 1161 was used to smooth out the repair area and SuperWrap II was applied in a patch form as a 6 layer system.

Propylene Line 100 F 50 psig Repair was designed with ASME Article 401
