Belzona SuperWrap II for Pitted Piping

ID: 8592

Industry: Power
Application: VPF-Valves, Pipes and Fittings
Substrate: Carbon Steel
Products: * Belzona 1212 ,
* Belzona 1161 (Super-UW Metal) ,
* Belzona 1982 ,
* Belzona 9381 ,

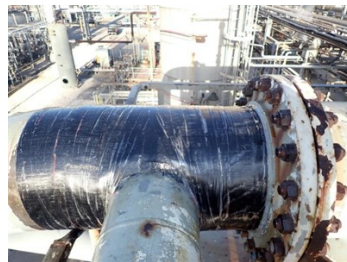
Localized corrosion in the form of deep pits was on the verge of holing through.

Piping near a cooling tower was severely corroded due to cooling tower mist.

Wire brush preparation was performed around critical defects. Belzona 1212 was then used to cover critical defects. Once Belzona 1212 became machinable, a MBX was used to create an SSPC-SP 11 surface cleanliness level on the surrounding good metal. Belzona 1161 was used to smooth out the repair area and SuperWrap II was applied in a patch form as a 6 layer system.

Propylene Line 100 F 50 psig Repair was designed with ASME Article 401
