Belzona SuperWrap II for Pitted Piping

ID: 8592

Customer Location: Houston
Application Date: March 2020

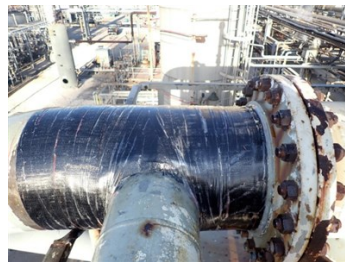
Localized corrosion in the form of deep pits was on the verge of holing through.

Piping near a cooling tower was severely corroded due to cooling tower mist.

Wire brush preparation was performed around critical defects. Belzona 1212 was then used to cover critical defects. Once Belzona 1212 became machinable, a MBX was used to create an SSPC-SP 11 surface cleanliness level on the surrounding good metal. Belzona 1161 was used to smooth out the repair area and SuperWrap II was applied in a patch form as a 6 layer system.

Propylene Line 100 F 50 psig Repair was designed with ASME Article 401

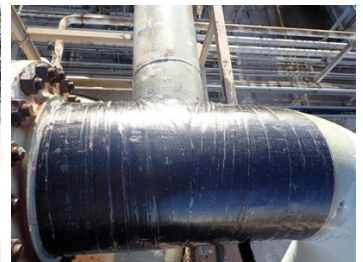
- * 1. Defective Asset ,
- * 2. Graphic for Design Package ,
- * 3-4. Final Repair ,
