Belzona Provides Abrasion Resistance to Chutes in Recycling Plant

Customer Location: Aluminium Ingot Plant, UK

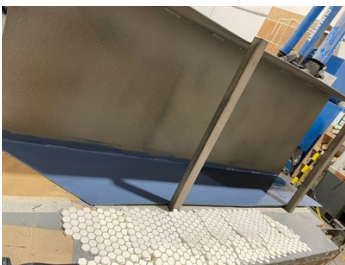
* 1. Newly fabricated chutes grit blasted and lined with Belzona 1321 2. Belzona 9811 Alumina tiles adhered to the Belzona 1321 3. Belzona 9811 Alumina tiles bonded in place using Belzona 1321 4. Newly fabricated abrasion-resistant chutes ready for delivery to the customer ,

New steel chutes were fabricated and delivered to Belzona Wrexham workshop. The chutes were then grit blasted, cleaned and degreased in preparation for the Belzona application. A single coat of Belzona 1321 (Ceramic S-Metal) was then applied. A sheet of Belzona 9811 (Alumina Tiles) was then tenaciously bonded into the Belzona 1321 which is used as an adhesive. Once cured, Belzona
