Belzona Provides Abrasion Resistance to Chutes in Recycling Plant

ID: 8595

Customer Location: Aluminium Ingot Plant, UK

Application Date: August 2021

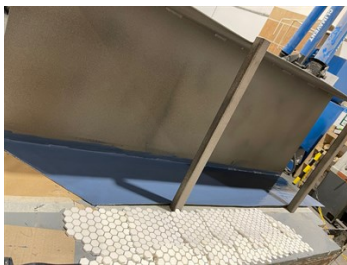
* 1. Newly fabricated chutes grit blasted and lined with Belzona 1321 2. Belzona 9811 Alumina tiles adhered to the Belzona 1321 3. Belzona 9811 Alumina tiles bonded in place using Belzona 1321 4. Newly fabricated abrasion-resistant chutes ready for delivery to the customer ,

New steel chutes were fabricated and delivered to Belzona Wrexham workshop. The chutes were then grit blasted, cleaned and deoiled in preparation for the Belzona application. A single coat of Belzona 1321 (Ceramic S-Metal) was then applied. A sheet of Belzona 9811 (Alumina Tiles) was then tenaciously bonded into the Belzona 1321 which is used as an adhesive. Once cured, Belzona
