# BELZONA SEALS UNSANITARY LEAKING FLOOR DRAIN IN FOOD PLANT

Customer Location: *Pet food manufacturer, O'Fallon, MO*  
Application Date: *June 2007*

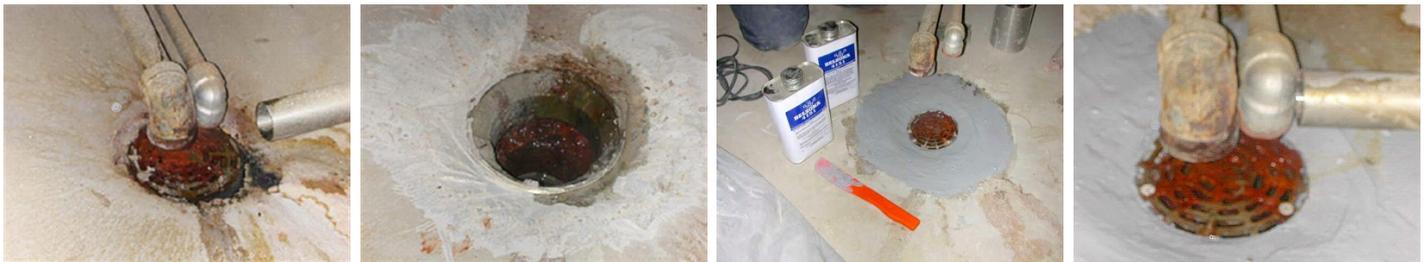
*Leak around drain allowed waste product into the sanitary production packaging floor below.*

- \* Unsanitary, leaking drain ,
- \* Surface prepared ,
- \* Belzona® 4111 installed ,
- \* Drain cover installed ,

Waste drain on 2nd floor above production packing area.

Application carried out in accordance with the Belzona Know-How System Leaflet FPA-1.
