BELZONA SEALS UNSANITARY LEAKING FLOOR DRAIN IN FOOD PLANT

ID: 860

Customer Location: Pet food manufacturer, O'Fallon, MO
Application Date: June 2007

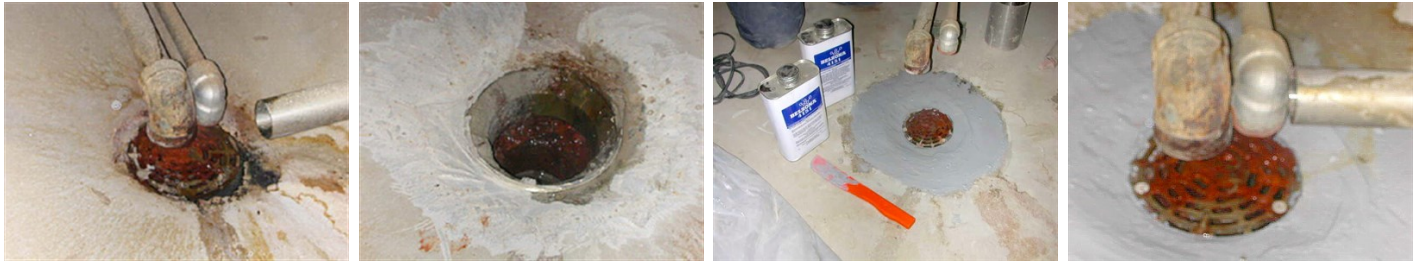
Photograph Descriptions

Leak around drain allowed waste product into the sanitary production packaging floor below.

- * Unsanitary, leaking drain ,
- * Surface prepared ,
- * Belzona® 4111 installed ,
- * Drain cover installed ,

Waste drain on 2nd floor above production packing area.

Application carried out in accordance with the Belzona Know-How System Leaflet FPA-1.
