Belzona Overhauls a Pump in a Waste Incineration Plant

Customer Location: Poland
Application Date: October 2021

Duchting Pumpen MC 300-500 after many years of operation was damaged by numerous body cracks and other damage.

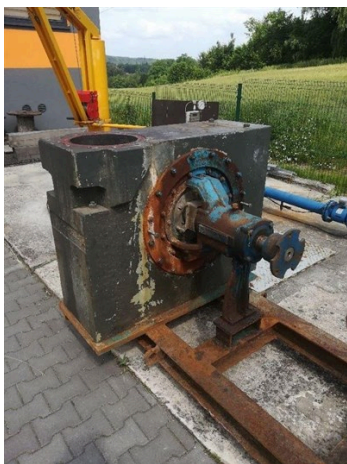
- * 1 - Damaged Pump ,
- * 2 - Cracked Casing to be repaired with Belzona 1111 ,
- * 3 - Internal Lining coated Belzona 1381 ,
- * 4 - Completed Application ,
