# Belzona Overhals a Pump in a Waste Incineration Plant

ID: 8620

Customer Location: Poland  
Application Date: October 2021

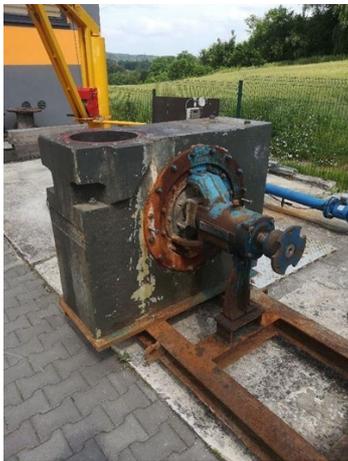
- \* 1 - Damaged Pump ,
- \* 2 - Cracked Casing to be repaired with Belzona 1111 ,
- \* 3 - Internal Lining coated Belzona 1381 ,
- \* 4 - Completed Application ,

Duchting Pumpen MC 300-500 after many years of operation was damaged by numerous body cracks and other damage.

- repair of pump body crack
- replenishment of cavities, protection of the rotor and body
