# Belzona protects clarifier track

ID: 8622

Industry: *Water / Wastewater*  
Application: *TCC-Tanks and Chemical Containment Areas*

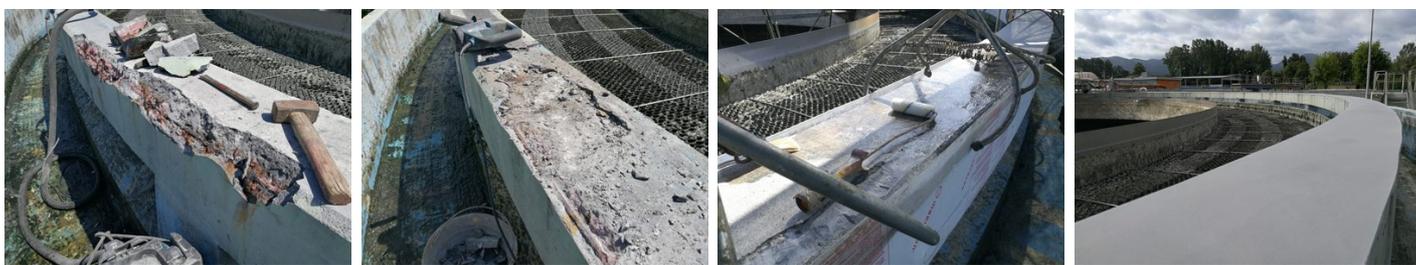
## Photograph Descriptions

*The damage on the track on the clarifier needed to be rebuilt to a smooth surface in order to allow the operation of the 'crane' unit.*

- \* 1. Removal of spooled and damaged concrete ,
- \* 2. Removal of spooled and damaged concrete ,
- \* 3. Conditioning of the substrate ,
- \* 4. Completed application ,

The track on an effluent clarifier had become damaged over time, so a solution was needed to rectify this.

Any loose material was removed and shuttering installed to the required height. The substrate was conditioned with Belzona 4911 and rebuilt with Belzona 4111.

The works to repair the entirety of the 80m tank circumference were completed in just 5 days.
