Belzona protects clarifier track

ID: 8622

Industry: *Water / Wastewater*
Application: *TCC-Tanks and Chemical Containment Areas*

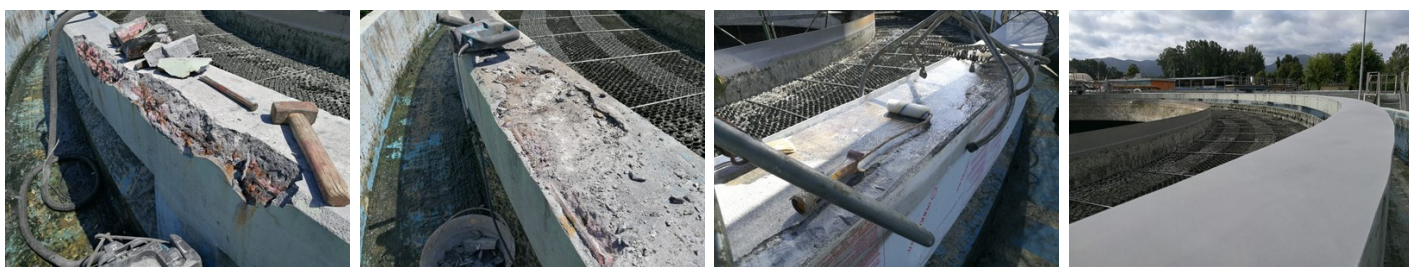
Photograph Descriptions

The damage on the track on the clarifier needed to be rebuilt to a smooth surface in order to allow the operation of the 'crane' unit.

- * 1. Removal of spooled and damaged concrete ,
- * 2. Removal of spooled and damaged concrete ,
- * 3. Conditioning of the substrate ,
- * 4. Completed application ,

The track on an effluent clarifier had become damaged over time, so a solution was needed to rectify this.

Any loose material was removed and shuttering installed to the required height. The substrate was conditioned with Belzona 4911 and rebuilt with Belzona 4111.

The works to repair the entirety of the 80m tank circumference were completed in just 5 days.
