# BELZONA RESEALS AROUND ROOFTOP A/C UNITS

Industry: Pulp & Paper  
Application: RPA-Roof Problem Areas  
Substrate: Tar, Aluminum paint and Belzona® 3111  
Products: Belzona® 3111 (Flexible Membrane)

Customer Location: Chic Lumber Co, OFallon, MO  
Application Date: July 2007

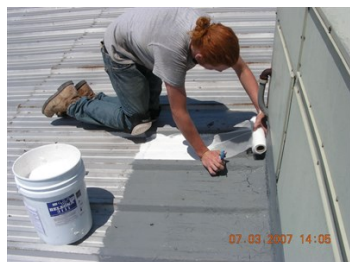
\* Start of the application , \* Sheet being incorporated in Belzona® 3111 coating , \* Application continuing , \* All sides waterproofed ,

Application was carried out in accordance with Belzona Know-How System Leaflet RPA-8
