BELZONA RESEALS AROUND ROOFTOP A/C UNITS

ID: 863

Industry: *Pulp & Paper*
Application: *RPA-Roof Problem Areas*
Substrate: *Tar, Aluminum paint and Belzona® 3111*
Products: *Belzona® 3111 (Flexible Membrane)*

Customer Location: *Chic Lumber Co, OFallon, MO*
Application Date: *July 2007*

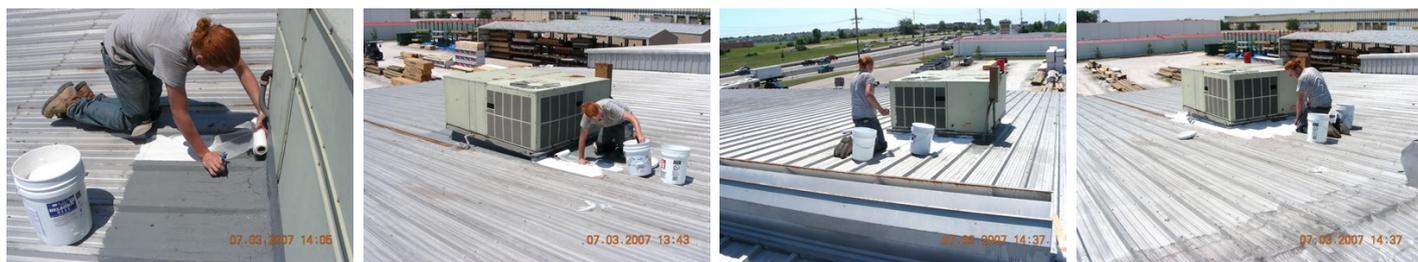
Photograph Descriptions

Over zealous painter overcoated Belzona repair with an aluminum paint that caused the Membrane to crack leading to roof leaks

* Start of the application , * Sheet being incorporated in Belzona® 3111 coating , * Application continuing , * All sides waterproofed ,

Application was carried out in accordance with Belzona Know-How System Leaflet RPA-8

Previous success of the Belzona® 3111 and reluctant admission of mistakenly applying aluminized paint over the Belzona® 3111 coating lead to re-installation of the Belzona. Reroofing was the alternative to repairing a small portion of the 25,000 sq ft roof.
