Belzona protects a loader

ID: 8630

Industry: *General Industry*
Application: *CEP-Centrifugal Pumps*
Substrate: *Steel*
Products: ** Belzona 4311 (Magma CR1) ,*

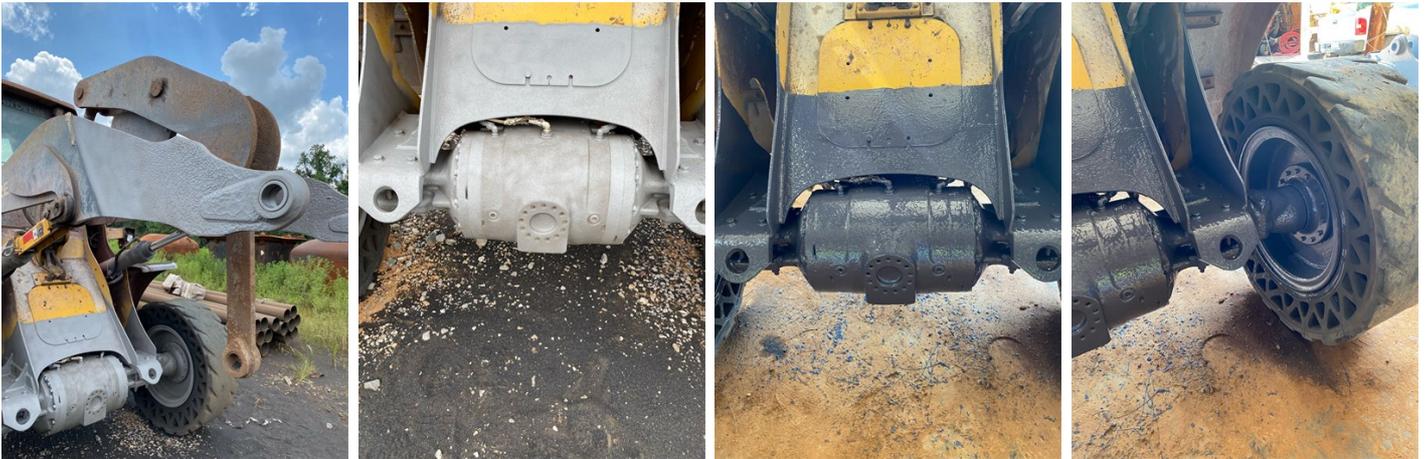
Photograph Descriptions

The metal on the front of the loader was being subjected to chemical attack due to the battery acid. A coating was required which would be able to protect it from further chemical attack due to exposure to the battery acids.

- * 1. Grit blasted area ,
- * 2. Grit blasted area ,
- * 3. Coating applied ,
- * 4. Coating applied ,

battery acid spillages onto the loader had caused the previous coating to fail, leaving the metal below open to chemical attack.

The areas that required protection were grit blasted back to white metal. Belzona 4311 was then mixed and applied.
