Belzona protects pumps for water treatment plant

ID: 8631

Industry: Water / Wastewater
Application: CEP-Centrifugal Pumps
Substrate: Steel
Products: * Belzona 1331 ,

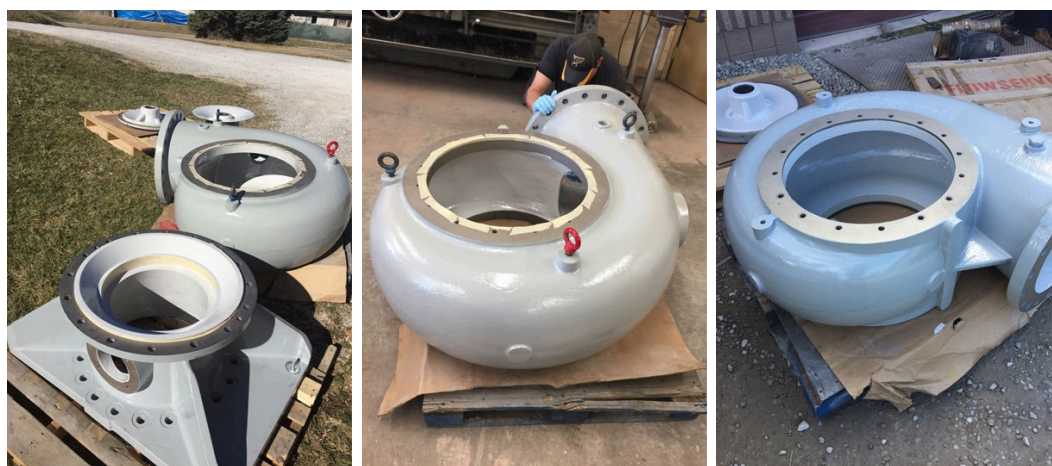
Photograph Descriptions

* 1-3. Completed application ,

Belzona 1331 was applied to the grit-blasted internals of the pumps
