# Belzona Protects Sewage Treatment Plant

ID: 8636

Customer Location: Poland  
Application Date: 2021

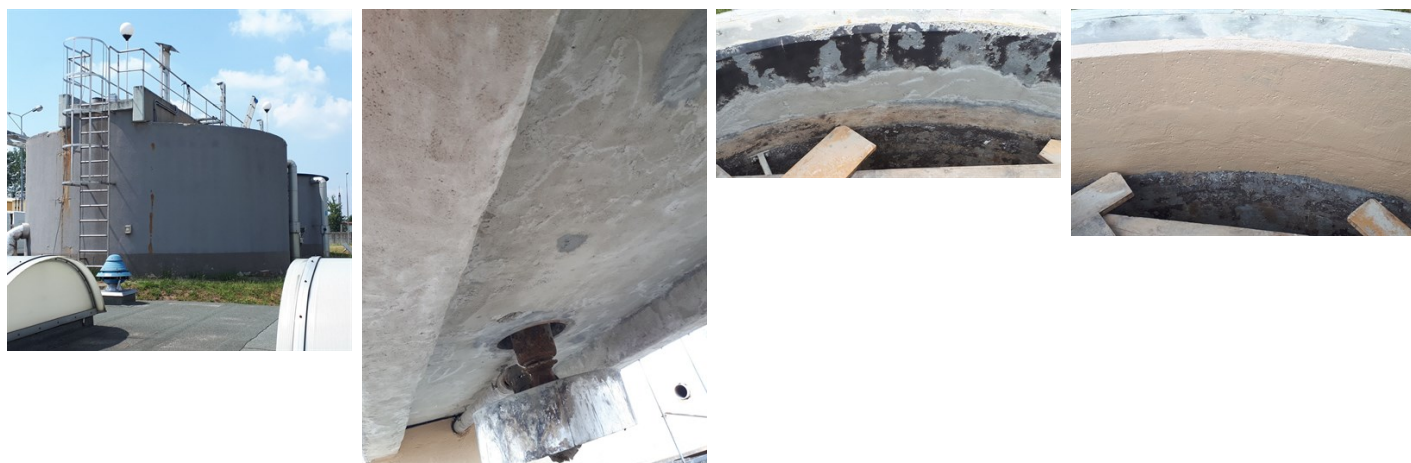
Strong and progressive corrosion of the concrete in the area of the sewage mirror and in the ceiling part of the sludge thickener.

- \* 1. Treatment tank ,
- \* 2. Area to be repaired ,
- \* 3. Area rebuilt ,
- \* 4. Area protected with Belzona 5811 ,

Deterioration on the surface of the raw sludge thickener in the sewage treatment plant, meant that repair and protection was required

The concrete defect areas were rebuilt and then protected using Belzona 5811
