BELZONA SOLVES BALANCE PROBLEM ON IMPELLER

ID: 864

Customer Location: ConocoPhillips Refinery, Wood River, IL
Application Date: July 2007

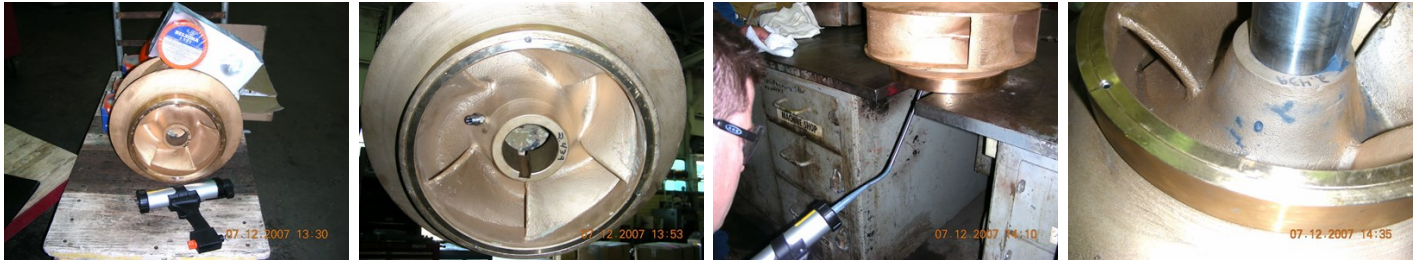
Photograph Descriptions

Liquid slowly entered the void during operation causing an imbalance and vibration.

* General view of the impeller , * Injection port fitted , * Injection underway , * Vent port filled after injection completed ,

Impeller did not have a solid center bore. Instead, it had a boss fit on both sides with a 60 cubic inch void in the center.

Belzona® 1321 was injected into the void, filling it completely. Application followed Belzona Know-How System Leaflet GSS-9
