# BELZONA SOLVES BALANCE PROBLEM ON IMPELLER

Industry: Oil & Gas  
Application: GSS-Gaskets, Seals and Shims  
Substrate: Bronze  
Products: Belzona® 1321 (Ceramic S-Metal)

Customer Location: ConocoPhillips Refinery, Wood River, IL  
Application Date: July 2007

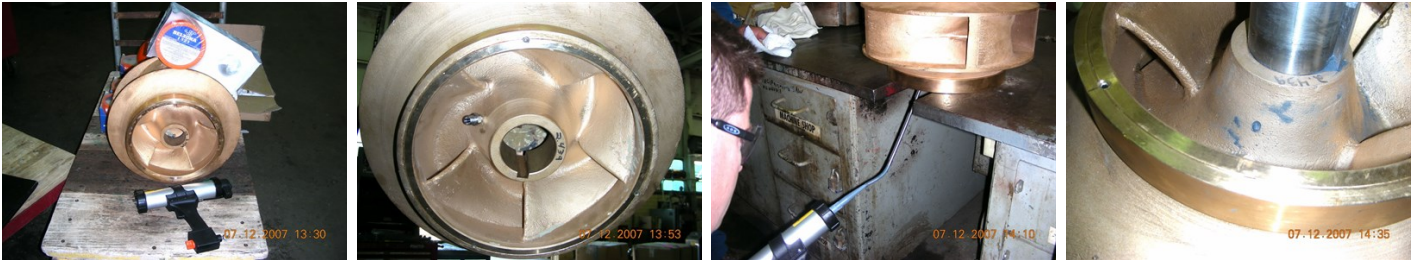
## Photograph Descriptions

Liquid slowly entered the void during operation causing an imbalance and vibration.

\* General view of the impeller , \* Injection port fitted , \* Injection underway , \* Vent port filled after injection completed ,

Impeller did not have a solid center bore. Instead, it had a boss fit on both sides with a 60 cubic inch void in the center.

Belzona® 1321 was injected into the void, filling it completely. Application followed Belzona Know-How System Leaflet GSS-9
