Belzona Flexible Membrane Protects Concrete Tower Foundation

Application: WPA-Wall Problem Areas

Substrate: Concrete

Customer Location: Nova Scotia, Canada

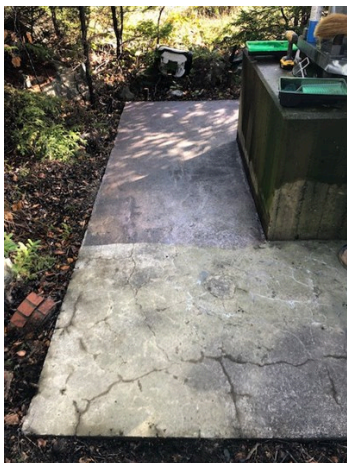
- * 1. Cleaned foundation. ,
- * 2. Foundation conditioned with Belzona 3911. ,
- * 3. Finished Belzona 3111 application. ,
- * 4. Membrane in good shape one year following application. ,

The coating application followed Belzona procedure WPA-1 for protecting and weatherproofing external surfaces. The foundation was first cleaned to remove all dirt and debris then conditioned with Belzona 3911. Once the Belzona 3911 dried, the Belzona 9311 reinforcement sheet was incorporated into the first coat of Belzona 3111. Once the first coat was adequately dry, the second coat of

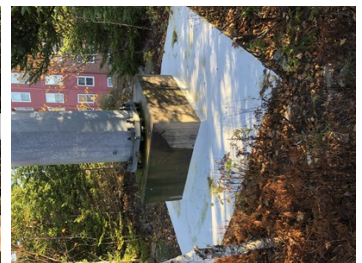
Epoxy coatings have not performed well with the utility for the purpose of preventing water from getting into foundation cracks. The Belzona 3111 membrane was used as a trial for the benefit that the membrane will keep water out, and is flexible which means no cracking like an epoxy coating. The second coat of Belzona 3111 membrane was applied several hours before a Fall rain storm. The Belzona 3111 Membrane was unaffected by the rain, and continued to cure once the weather dried up. One year after the application and the membrane is still in good shape with water ponding on the top.
