Belzona Flexible Membrane Protects Concrete Tower Foundation

Application: WPA-Wall Problem Areas

Customer Location: Nova Scotia, Canada

Application Date: October 2020

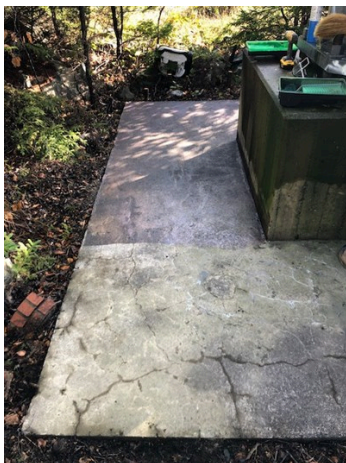
This concrete foundation for a large electrical transmission tower had several large cracks that were exposed to water ingress. General epoxy coatings were found to be too brittle and also prone to cracking to fully prevent water from getting into the foundation. Water entering through these cracks makes the foundation susceptible to freeze thaw damage, and contributes to rebar corrosion.

- * 1. Cleaned foundation. ,
- * 2. Foundation conditioned with Belzona 3911. ,
- * 3. Finished Belzona 3111 application. ,
- * 4. Membrane in good shape one year following application. ,

The coating application followed Belzona procedure WPA-1 for protecting and weatherproofing external surfaces. The foundation was first cleaned to remove all dirt and debris then conditioned with Belzona 3911. Once the Belzona 3911 dried, the Belzona 9311 reinforcement sheet was incorporated into the first coat of Belzona 3111. Once the first coat was adequately dry, the second coat of

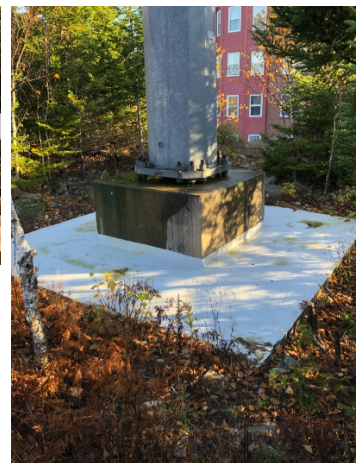
Epoxy coatings have not performed well with the utility for the purpose of preventing water from getting into foundation cracks. The Belzona 3111 membrane was used as a trial for the benefit that the membrane will keep water out, and is flexible which means no cracking like an epoxy coating. The second coat of Belzona 3111 membrane was applied several hours before a Fall rain storm. The Belzona 3111 Membrane was unaffected by the rain, and continued to cure once the weather dried up. One year after the application and the membrane is still in good shape with water ponding on the top.
