# SUMP REPAIR WITH BELZONA AT YEAST PLANT

Industry: General Industry  
Application: FPA-Floor Problem Areas  
Substrate: Concrete  
Products: Belzona® 4111 (Magma Quartz)

Customer Location: Yeast Producer, Memphis, TN  
Application Date: March 2007

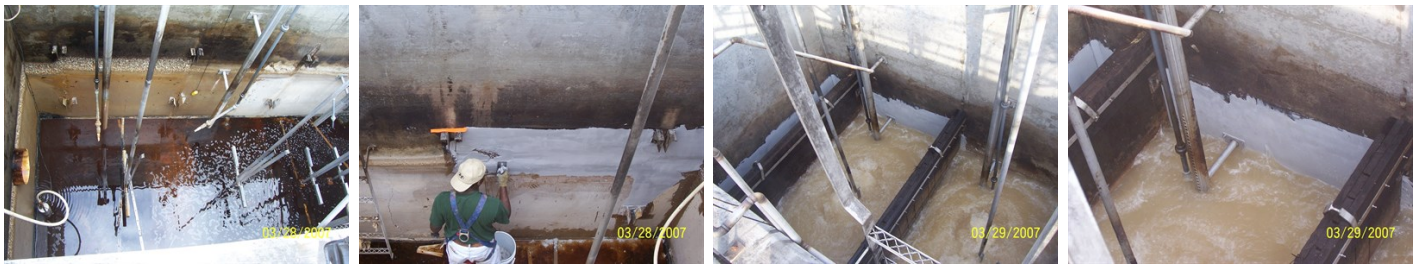
After years of running 24 hours a day, 7 days a week the sump had erosion and corrosion from chemical attack at the water level.

\* Sump prior to repair , \* Sump under repair , \* Sump after repair , \* Sump after repair ,

This application was carried out in accordance with Belzona Know-How System Leaflet FPA-10.

The Belzona® 4111 will hold up to the the chemical attack providing long life to the sump. The Belzona solution provided the customer the ability to be back on-line in under 24 hours.
