# Belzona SuperWrap II Patch Repairs Leaking Vessel Welds

ID: 8666

Industry: *General Industry*  
Application: *TCC-Tanks and Chemical Containment Areas*

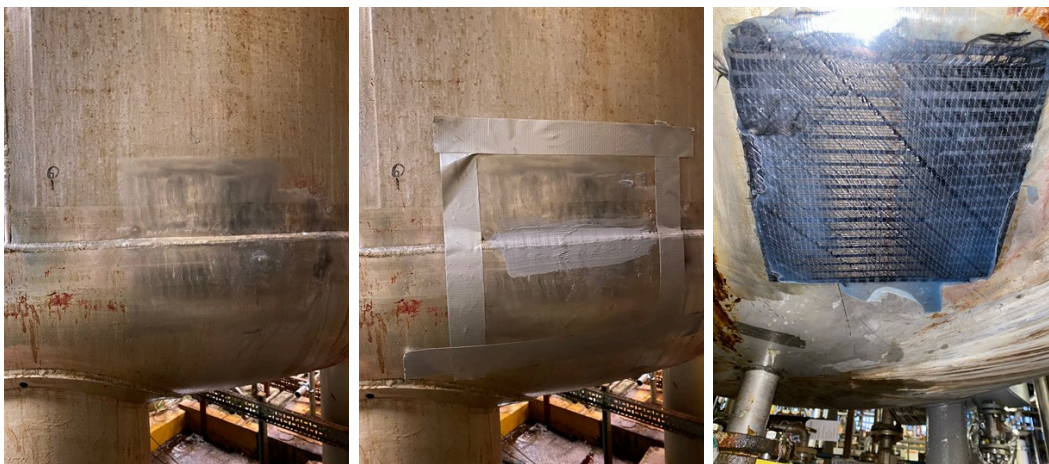
- \* 1 - Surface preparation carried out ,
- \* 2 - Belzona 1111 applied to fair the surface ,
- \* 3 - Wrap system applied & consolidated using formers & straps to compress ,

Stainless steel vessels had developed pinhole leaks around welds. A cold applied & fast back to service repair was required to seal these leaks during a shutdown.

The areas were first prepared using an MBX Bristle Blaster. Belzona 1111 Supermetal was applied to fair any defects. A four layer patch system was created using Belzona 1981 SuperWrap II resin, and Belzona 9381 reinforcing sheet. This application was completed in accordance with Belzona system leaflet TCC-1.
