Belzona SuperWrap II Patch Repairs Leaking Vessel Welds

ID: 8666

Industry: General Industry
Application: TCC-Tanks and Chemical Containment Areas

Customer Location: Scotland
Application Date: October 2021

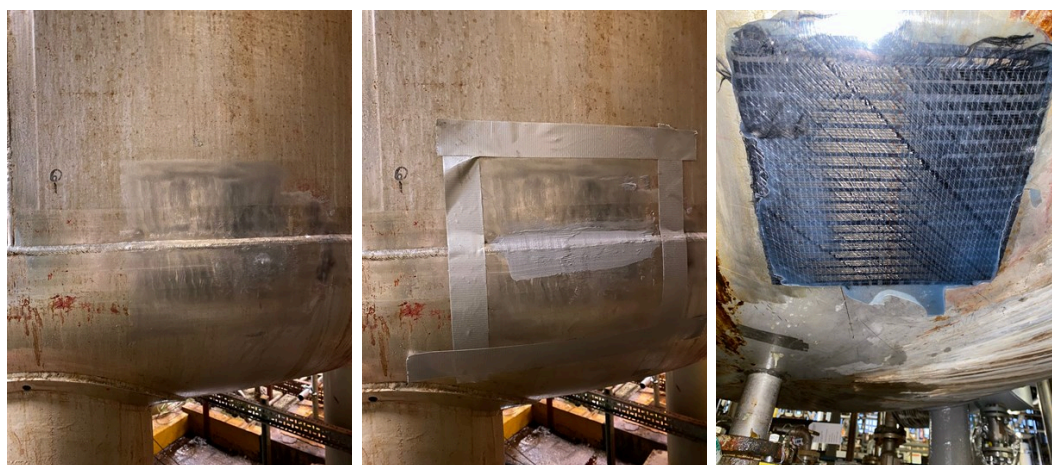
Photograph Descriptions

- * 1 - Surface preparation carried out ,
- * 2 - Belzona 1111 applied to fair the surface ,
- * 3 - Wrap system applied & consolidated using formers & straps to compress ,

Stainless steel vessels had developed pinhole leaks around welds. A cold applied & fast back to service repair was required to seal these leaks during a shutdown.

The areas were first prepared using an MBX Bristle Blaster. Belzona 1111 Supermetal was applied to fair any defects. A four layer patch system was created using Belzona 1981 SuperWrap II resin, and Belzona 9381 reinforcing sheet. This application was completed in accordance with Belzona system leaflet TCC-1.

These cold applied patch repairs were completed in one day, saving the customer time & money.
