BELZONA REPAIRS BIODIESEL COLUMN

Customer Location: Biodiesel Producer, Memphis, TN
Application Date: November 2006

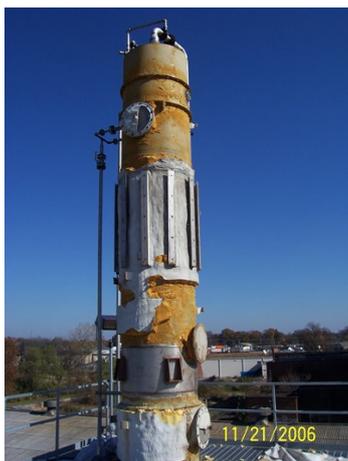
Due to stress on a flange there was a crack at the weld causing Biodiesel to leak. This was 130 feet above the ground.

* The column to be repaired , * Column under repair , * Repaired area on column , * Repaired area close-up ,

Application was carried out in accordance with Belzona Know-How System Leaflet CEP-3 & 6.

The Belzona solution offered the customer quick turn-around, without the expense of having to empty the column which they would have had to do if welding.
